LONG-TERM EFFECTS OF HAIL IMPACT ON ASPHALT SHINGLES—AN INTERIM REPORT

SCOTT J. MORRISON
Haag Engineering Co.
Carrollton, Texas, U.S.A.

A laboratory study was begun in 1983 to determine the long-term effects of hail on asphalt shingles. Simulated hailstones were launched at speeds of same-sized natural hailstones perpendicular to roofing panels constructed to replicate standard applications. Impacts were made on new fiber glass-reinforced three-tab, organic-reinforced three-tab and fiber glass-reinforced laminated shingles at the beginning of the study and after approximately 11 years of natural weathering exposure. The study confirmed that dents in asphalt shingles caused by impacts that did not initiate fractures did not change measurably over time and, hence, were not functional damage. Additionally, it was demonstrated that hail-damaged areas in shingles do not increase measurably in size with increased time of exposure. This has been found to be true whether the impact damage occurred to new shingles or to weathered shingles. It is important that functional damage to shingles caused by impacts was immediate and identifiable. This interim report is issued after 15 years of te

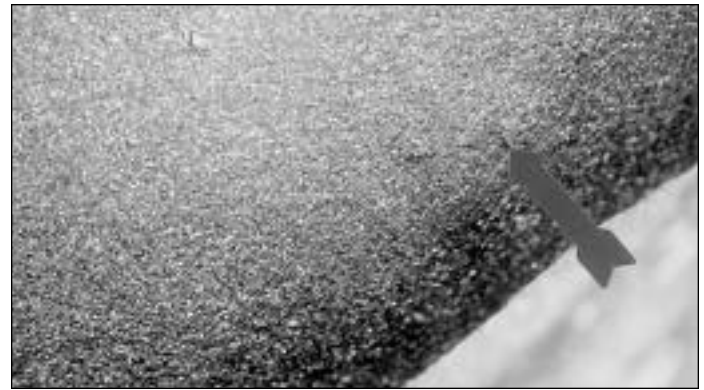
All panels were inspected at approximately 11 years exposure time (Year 11). Additionally, those panels designated originally for impacting at Year 7 were impacted and inspected. Generally, weathering-caused cracks meandered across shingles, with many cracks nearly parallel to butts and some parallel to ends. Some granules had been shed from ends, especially from butts of shingles; some tabs had curled. Examination at sites which were impacted at the initiation of the study but did not fracture at that time showed no identifiable changes in granule coverage. Examination at impact sites with fractures and comparison with photographs taken at 0- and 9-year exposure times showed no visible changes in fracture lengths but did show, in some instances, wider cracks and substantial loss of granules along fracture edges. Here, exposed asphalt was of weathered gray colors, and fracture edges were rounded and tapered. Table 6 lists results of impact testing. See Photos 5, 6 and 7.

Photo 5. Close-up on bottom side of D-7 of half-panel designation CO-TS-D-7 at impact site. Note single-line fracture pattern weathered 4 years 4 months.

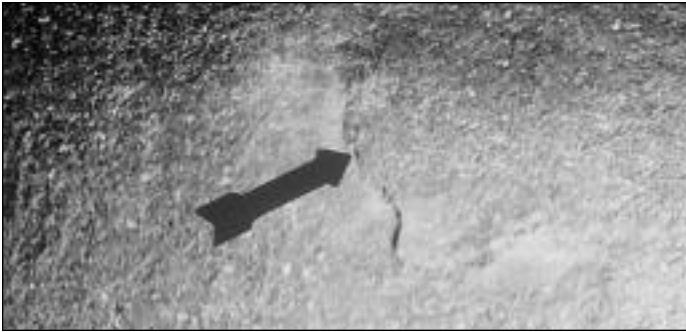
Photo 6. Close-up on bottom side of Tab D-4 of half-panel designation CO-FS-D-7 at impact site. Note curved-line fracture pattern weathered 4 years 4 months.

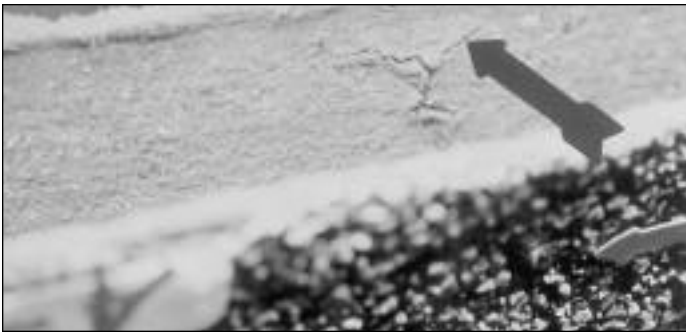
Photo 7. Close-up on bottom side of Tab A-5 of half-panel designation CO-WFB-D-7 at impact site. Note multi-line fractures radiating from common point.

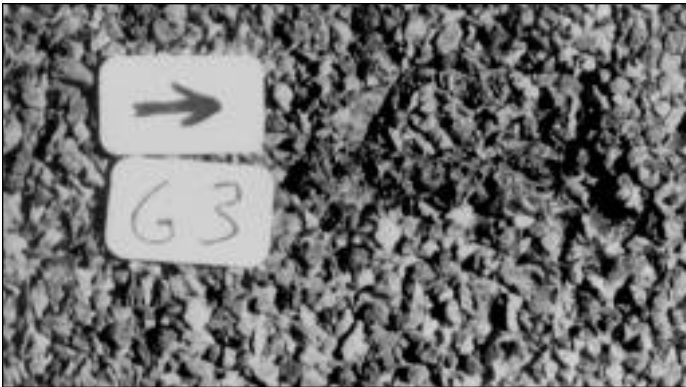
colored asphalt was visible at several locations in the laminated shingles impacted previously. With the blade of a penknife, these areas were probed and scraped carefully. A continuous bed of granules was detected immersed fully in asphalt. The frequency of fractures caused by impacts of 1-inch- (25-mm-) diameter freezer ice balls for all types of shingles tested in this study is presented in Table 7. Typical observations of an impact site with fractures are depicted at 10 years 6 months and 14 years 11 months in Photos 8 and 9, respectively. Photo 10 depicts asphalt underlaid with granules.

Photo 8. Close-up of Tab G-3, half-panel designation CO-FS-D-0 at 10 years 6 months weathering exposure. Note impact-caused fracture.

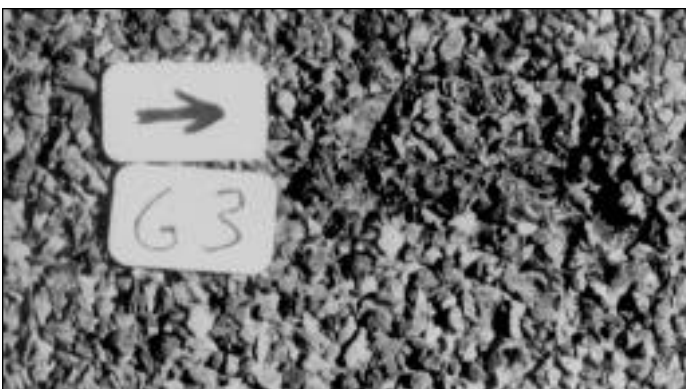
Photo 9. Close-up of Tab G-3, half-panel designation CO-FS-D-0 at 14 years 11 months weathering exposure. Note impact-caused fracture.

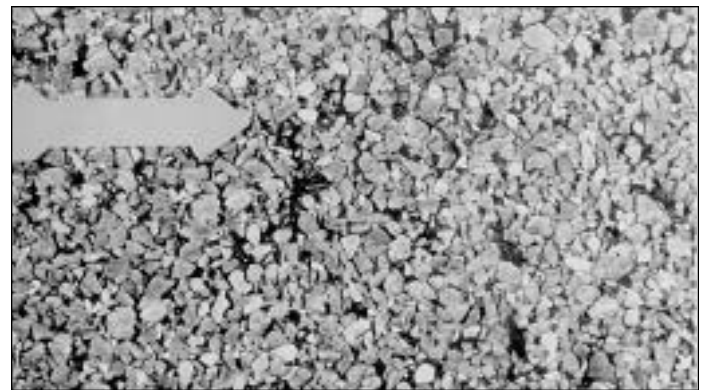
Photo 10. Close-up of D-2 of half-panel designation CO-TS-D-0 at 14 years 11 months weathering exposure. Note that granules were detected below the asphalt in vicinity of arrow.

- Some impacts made with freezer ice on laminated shingles dislodged granules from exposures without exposing asphalt. Granules subsequently were shed at impact locations over time with natural weathering. Careful examination at these locations revealed a continuous bed of granules immersed in the asphalt. There was no reduction in the expected service life of the shingles as granules on the shingles continued to protect the underlying asphalt and reinforcement. The condition was not functional damage but merely a cosmetic condition.

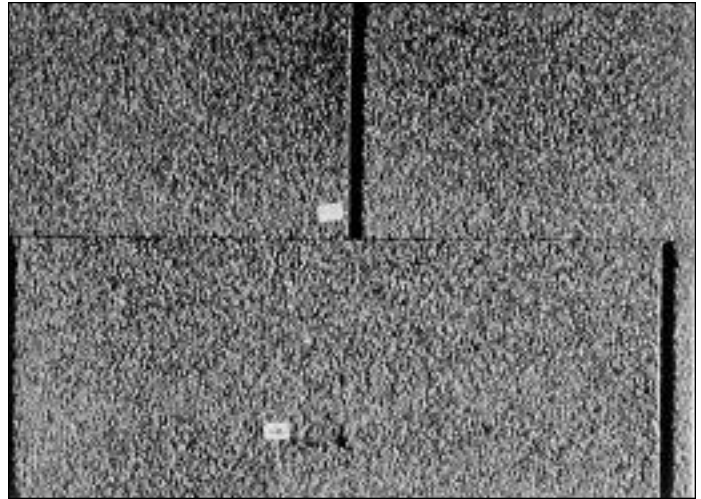
Photo A3. Close-up at Tab G-3 at 10 years 6 months weathering exposure. Note fracture.

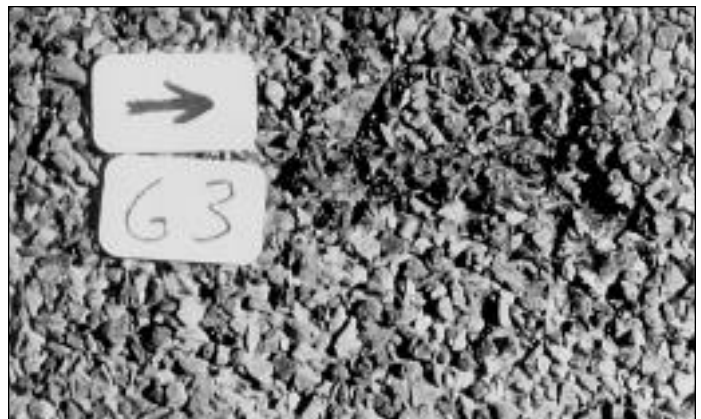
Photo A4. Close-up at fracture in Photo A3.

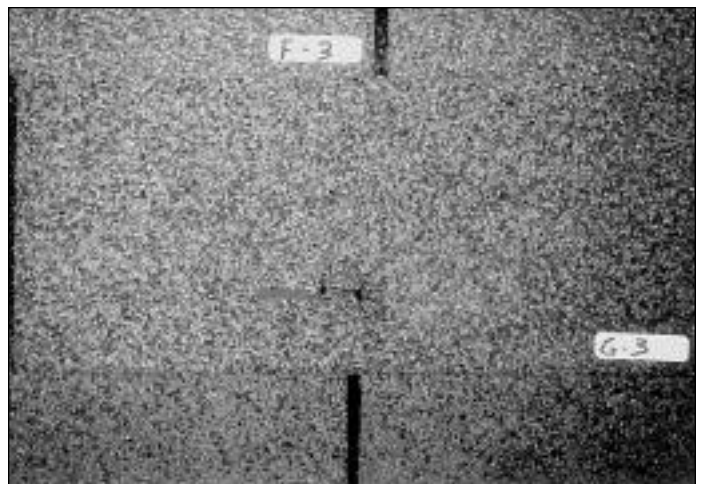
Photo A5. Close-up of Tab G-3 at 14 years 11 months weathering exposure. Note impact-caused fracture.

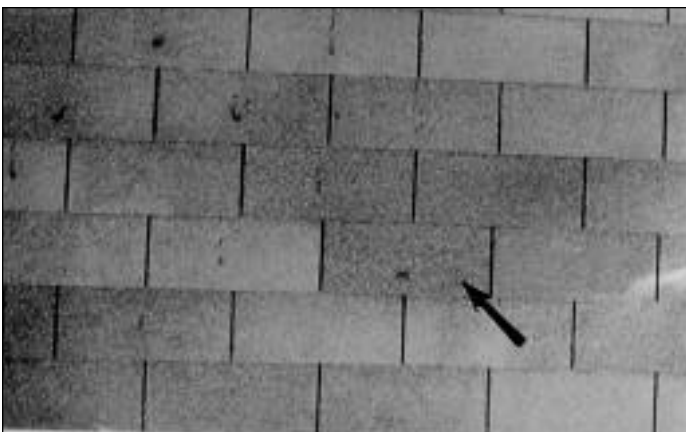
Photo A2. View of test panel at Year 0 after impacting. Note fracture in Tab G-3.

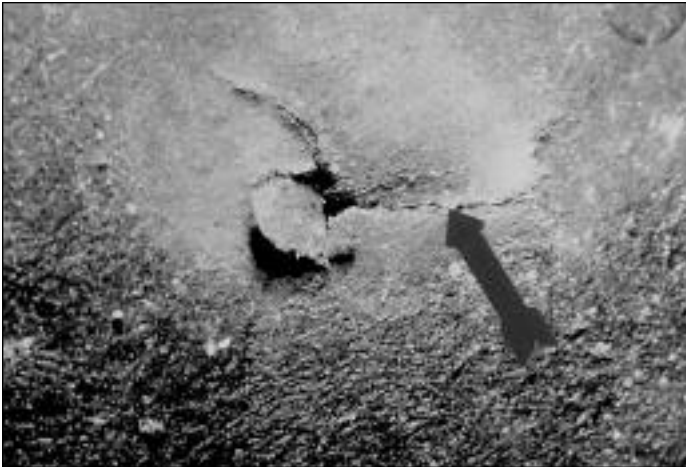
Photo A7. Close-up on bottom side of Tab G-3 at area depicted in Photo A6.

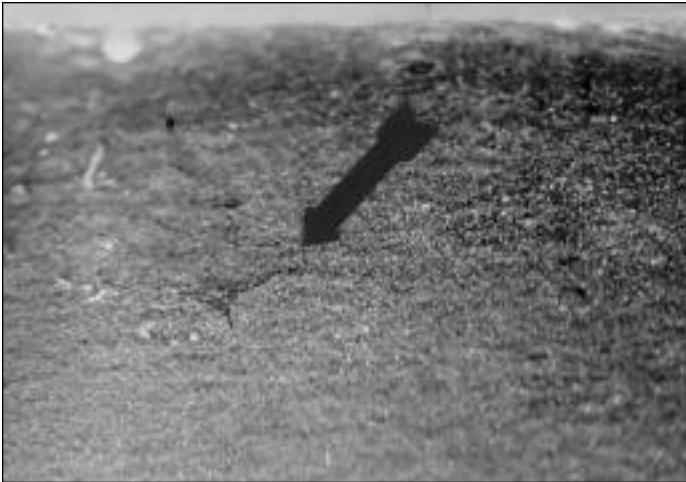
Photo C6. Close-up on bottom side of Tab C-5 at area depicted in Photo C5. Note fracture.

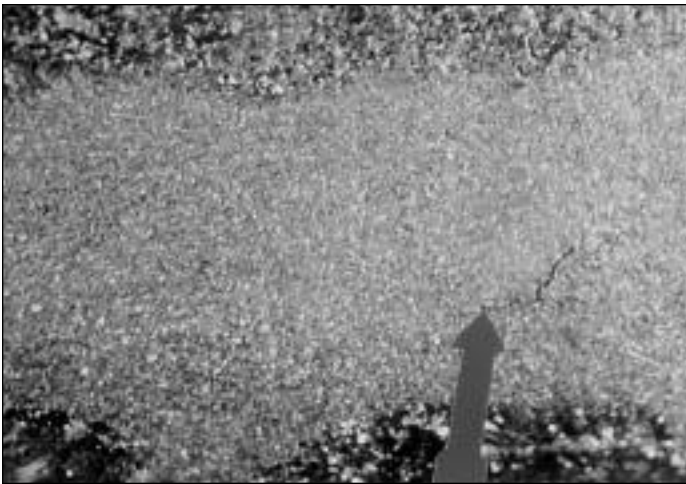
Photo D6. Close-up on bottom side of D-10 at location depicted in Photo D5. Note fracture.
